# City of Raleigh Parks and Recreation

## Appendix

## Chapter 6 | Appendices

Appendix items 6.1 and 6.2 include results of the individual park and greenway network observations. A sampling of eighty-one parks and facilities and thirty-five miles of greenway trails were observed by the Project Team over a two week period in October, 2012. Parks and facilities are listed alphabetically in **Table 12**, with identifying scores for each category, weighted overall scores and category score summaries on the last page. Greenway results are listed in **Table 13**. Sample evaluation forms are included at the beginning of each section.

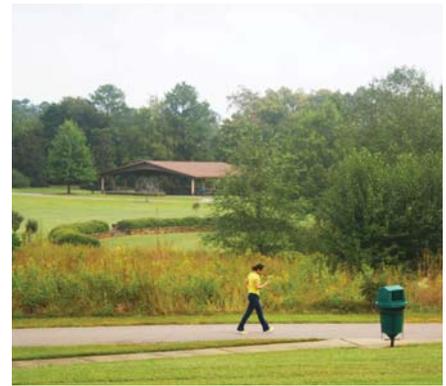
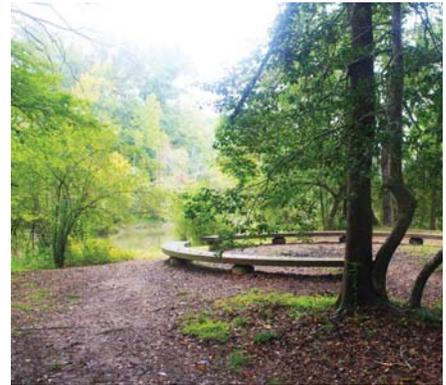
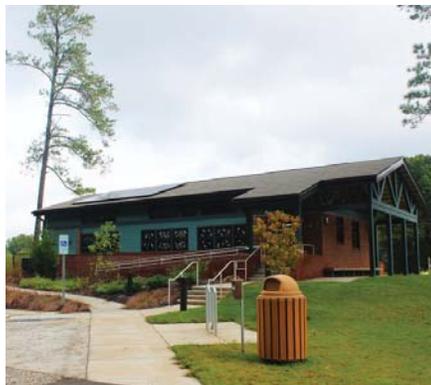
Anderson Point is limited on stormwater management techniques utilized throughout the site. Due to limited access points, site is not complementary of multi-modal uses, limited to vehicle and pedestrian/cyclist access. Existing structures are limited in energy efficiency techniques.

- Accessibility to confluence area of park is limited
- Canoe launch and associated parking drains directly into Neuse River
- Programming opportunities such as yoga classes, walking clubs

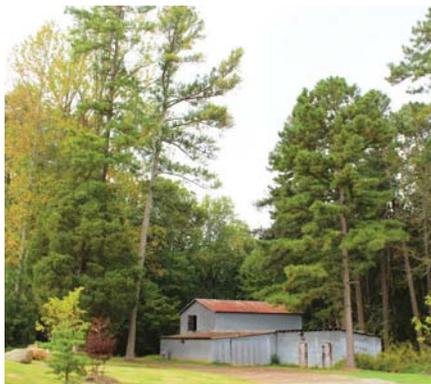
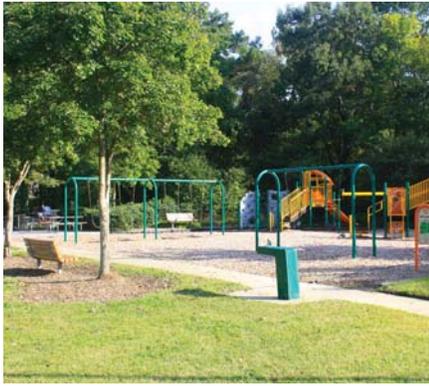
## 6.1.2 - Annie Louise Wilkerson M.D. Nature Preserve

Stormwater management is well handled on-site. Existing facilities are energy efficient. Site is limited in multi-modal choices to vehicles only due to a lack of sidewalks into the park.

- Accessibility may be improved into park with sidewalk connections
- Future Nature Center will increase activities at site
- Future trails should offer accessible hard surfaces where appropriate

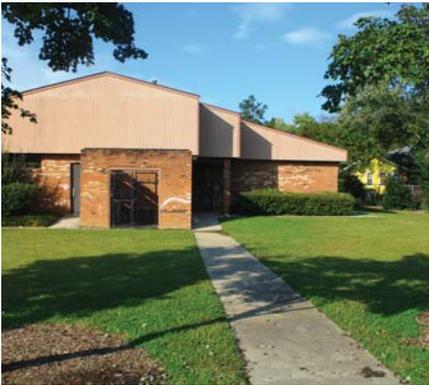
## 6.1.3 - Apollo Heights Size: 4.26 acres

Site is a model for multi-modal access for small parks. Energy efficiency is limited to upgrades at neighborhood center. Direct stormwater drains into Walnut Creek system.

- Site may improve direct stormwater runoff
- Highlight trail connectivity through park into adjacent neighborhood
- Playground has drainage problem and may lack accessibility if not maintained

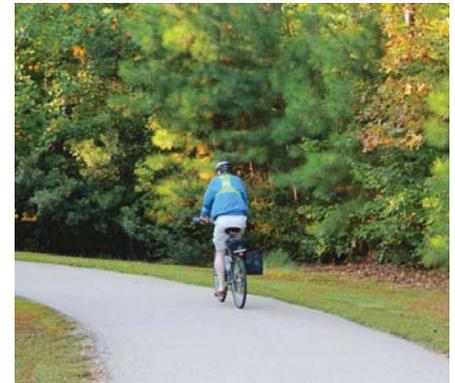
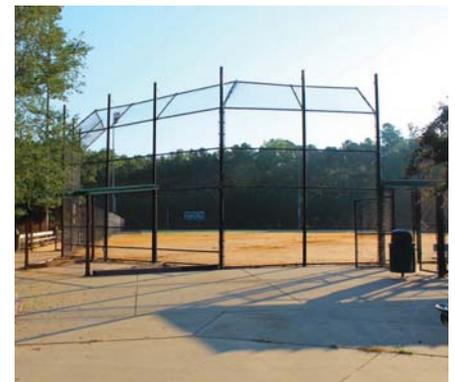
Existing facilities lack sustainable design and techniques. Direct stormwater runoff impacts surrounding properties. Limited multi-modal options for users.

- Direct sidewalk access to park is needed
- Lighting in parking and fields is not energy efficient
- Accessibility in playground may need to be improved

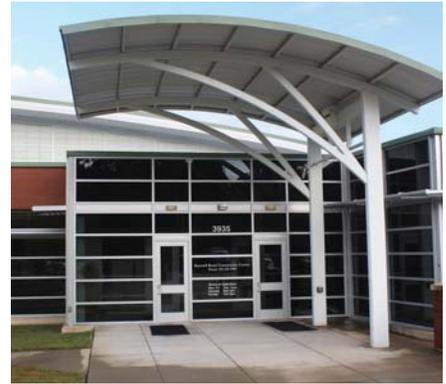
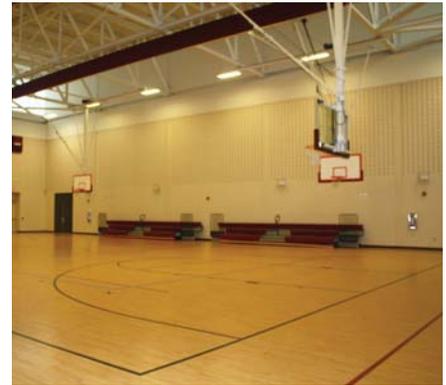
Closed stormwater system limits opportunities to treat run-off on site or near building. Site is only accessible to vehicle traffic, limiting multi-modal choices. Utilities are managed by school district. Most of site is floodplain and streams.

- Accessibility to park from adjacent roadways with sidewalks is limited
- Programming choices for elderly and adults lacks due to available hours
- Stormwater management on site may be improved

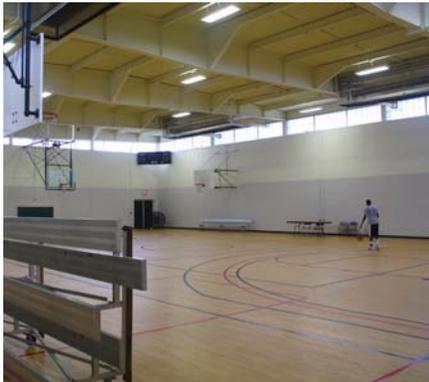
Park is heavily used and programmed. Open views from most directions promote a feeling of safety. Hardscapes are cracked/ uneven while Community Center is older but well maintained. Exterior shelters are older and not well maintained. Landscape needs refreshing.

Topography limits stormwater treatment with direct runoff and closed system existing. Community Center has new energy efficient lighting and A/C. Transit access could be improved directly to park.

- Coordinate pool season with shelter needs for users
- Air-conditioning for Gym is not provided
- Landscaping is aged and lacks sustainable, low impact, yet hardy species

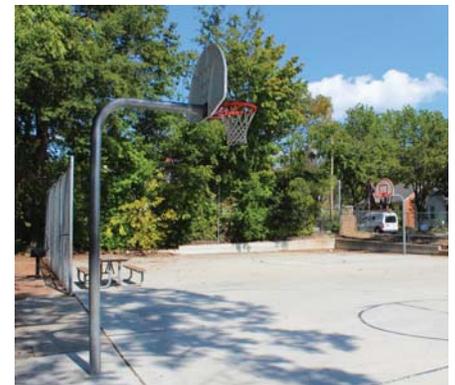
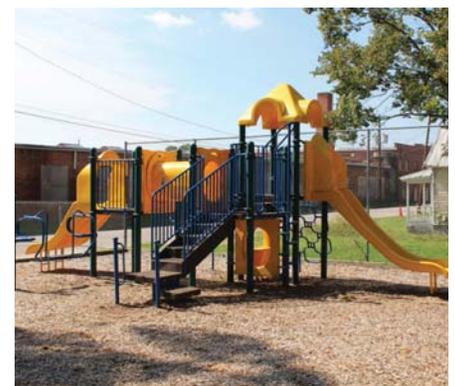
Park is heavily used with litter and evidence of loitering. Vacant buildings and few eyes on park limit feeling of safety. Pavement is old and crack with few seating options. Few stewardship techniques utilized.

Direct stormwater runoff to adjacent parcels, with limited space on site for treatment. Excellent multi-modal access with on-street parking, transit, cyclist access with potential for pedestrian access if sidewalk network is completed.

- Accessibility via sidewalk network to park is limited
- Increase active patrolling of park to discourage problematic loitering
- Hardscape surfaces are aged and cracked

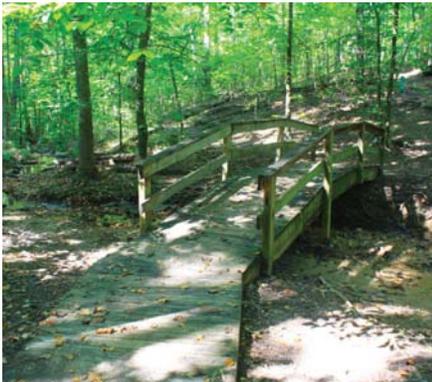
Care of park is not consistent with other parks. Natural vegetation hides developed areas of park from surveillance. Pavement is cracked and uneven throughout with limited seating options and a small shelter.

Parking utilizes solar lighting, however, poor multi-modal options requires parking for vehicles in a neighborhood area.

- Accessibility into park lacks clearly defined routes and sidewalks
- Trail hardscape (asphalt) is cracked and uneven
- Limited protection from weather for users by shelters

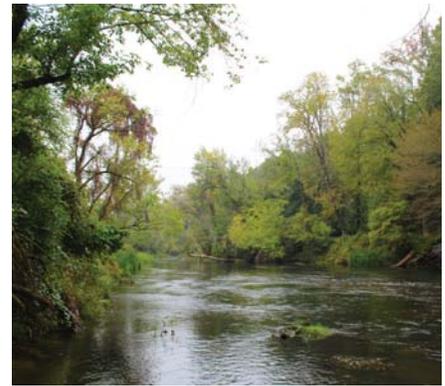
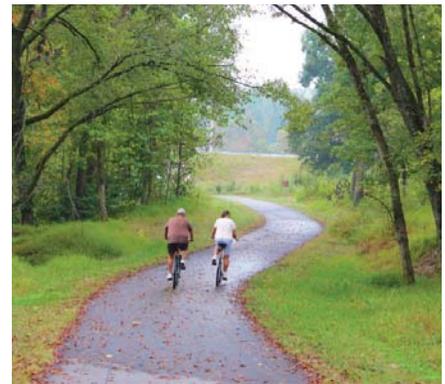
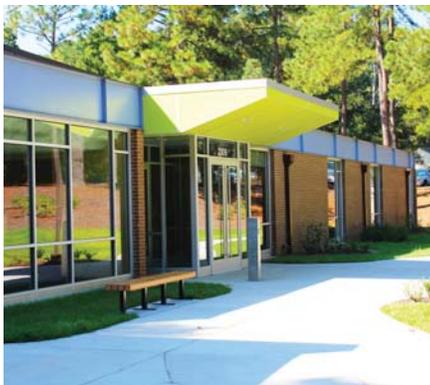
## 6.1.13 - Canoe Launch at Falls Lake Size: 9.13 acres

Site is energy efficient with solar lighting and limited infrastructure. Stormwater is mostly direct runoff and limited multi-modal capacity is available given the site size and location.

- Direct sidewalk access lacks
- Protection from weather with shelters lacks
- Programming at site may encourage use by multiple age groups

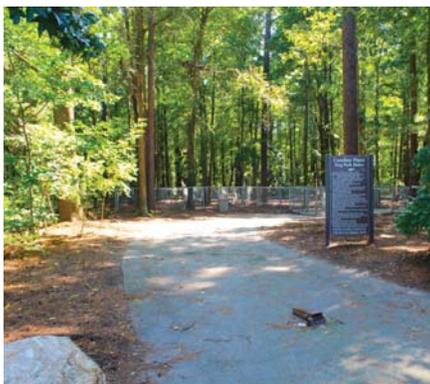
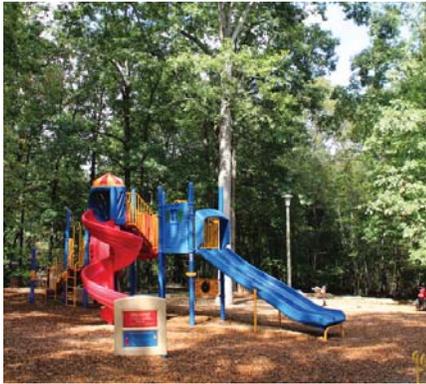
## 6.1.14 - Carolina Pines Size: 38.71 acres

Renovations at Community Center are examples of sustainable techniques with rain garden and energy efficiency. Transit access encourages multi-modal uses with an option for a park and ride facility. Most of site has direct runoff of stormwater.

- Park could be used as Park and Ride if routing and land uses permit
- Shelters for rentals lack in key locations
- Dog park lacks shelter with accessible hard surface access

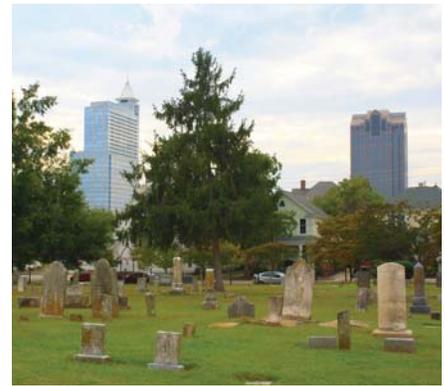
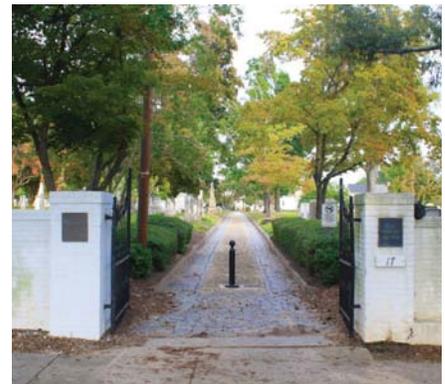
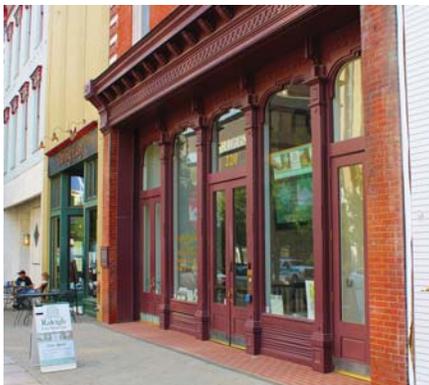
## 6.1.17 - City Cemetery

Cemetery is extremely well maintained and clean. Existing facility is maintenance only with no protection from weather and no shaded seating options. Some tombstones need repair due to age.

All stormwater is treated on site with limited direct run-off. Multi-modal connectivity and incorporation of a fire station next door creates a civic node.

- Educational signage could be added
- Promote sustainability with energy efficient lighting
- Site offers historic tours to public

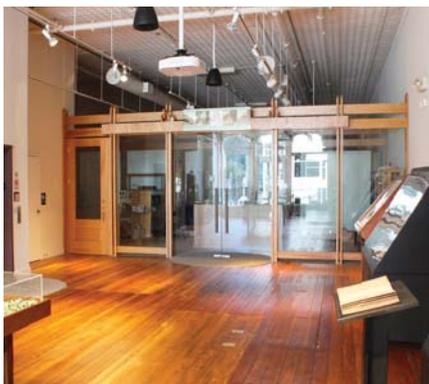
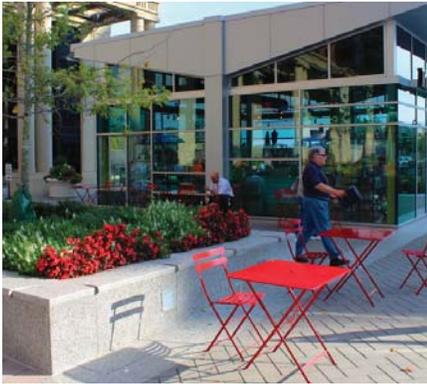
## 6.1.18 - Raleigh City Museum

Stormwater drains into closed system with no treatment. Multi-modal access is promoted within museum with a strong integration of non-profits within building.

- Energy efficiency within museum could be promoted
- Indoor seating for patrons of museum is lacking
- Roof stormwater could be treated on site

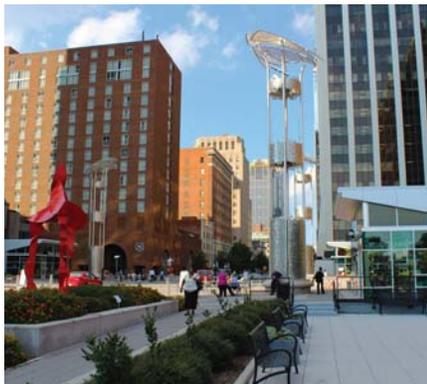
## 6.1.19 - City Plaza Size: 1.11 acres

Pavement consists of semi-permeable pavers, however, entire plaza is located on top of parking garage with limit opportunities for treatment of stormwater. Site promotes multi-modal access and lighting used is energy efficient.

- Shaded seating choices could be improved
- Better signage of space could promote area as community plaza

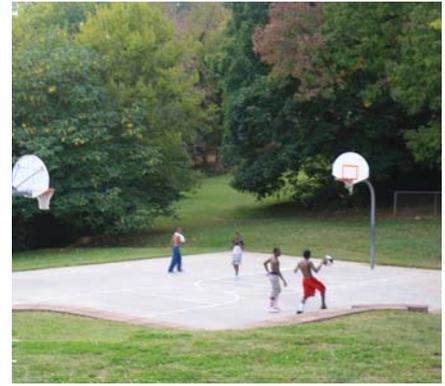
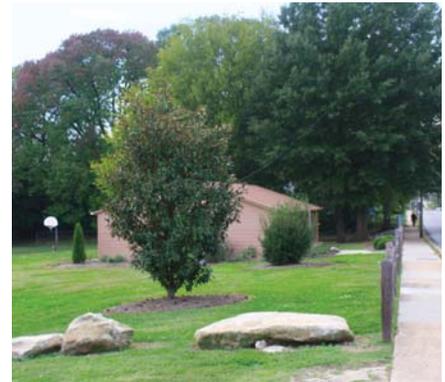
Direct stormwater runoff onto adjacent properties has negative impact. Multi-modal choices promote transit and walking to site. Energy efficiency is lacking on site.

- Energy efficiency at shelter could be improved
- Increase treatment of on-site stormwater
- Promote better use of limited open space through landscape

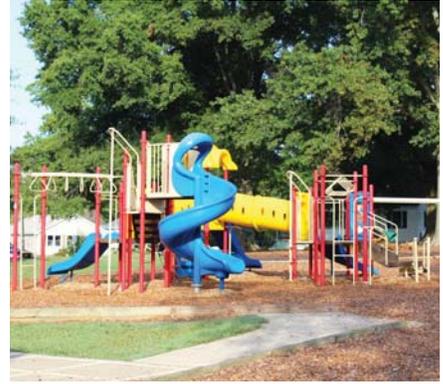
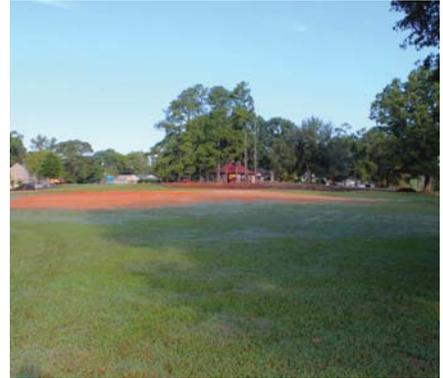
Some stormwater runoff is channeled directly to streets. Parking is limited, but could be increased on-street. Impact of future use of Water Works site could change needs for park. Energy efficient lighting could be provided around park. Remove portable restrooms.

- Accessible crosswalks to park from adjacent roads is lacking
- Erosion and sod issues on multi-purpose field and temporary restrooms
- Consider opportunities of future plans for Water Works site

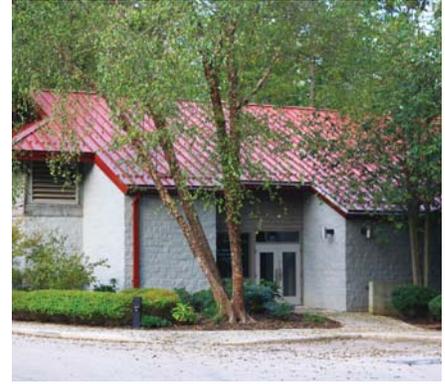
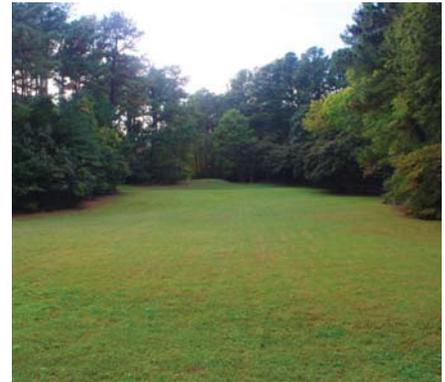
Most of site uses direct runoff with some water management on-site with a small lake which treats nearby neighborhood stormwater runoff. Multi-modal opportunities are centered on vehicle and trail accessibility.

- Basketball courts are forced into site and appear under-used
- Shelters are needed near playground and tennis courts are lacking
- Rental center at main entrance is not programmed daily

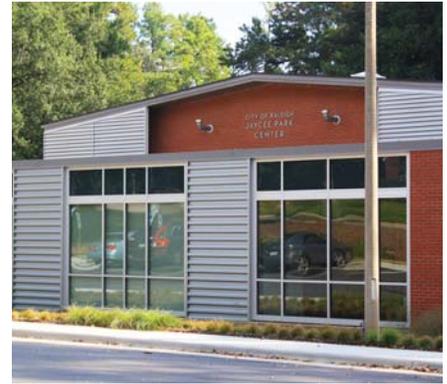
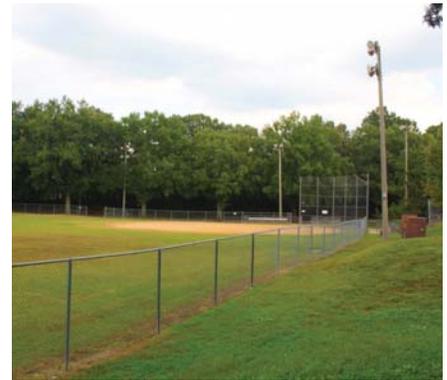
Renovations at community center offer excellent examples of sustainable techniques, but most of site has direct stormwater runoff to adjacent properties. Multi-modal transportation is offered with electrical charging stations for vehicles.

- Flexibility for lighted multi-purpose fields is minimum
- Direct stormwater runoff sited and recycle area needs cleaned up
- Additional shelters would increase opportunities for special use and rentals

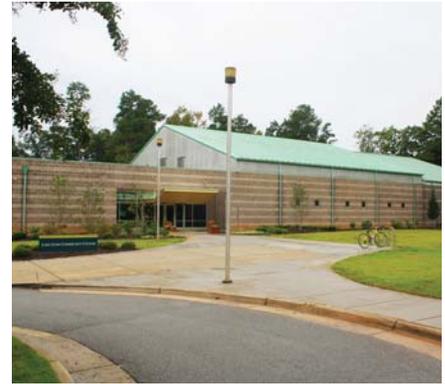
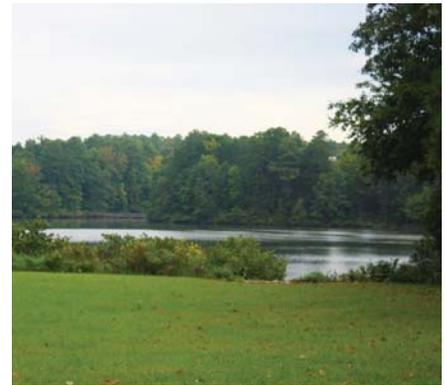
Park is centered on a large lake which provides water management for region. Lake is one of main amenities of park. Sidewalk connectivity would increase multi-modal choices to access park.

- Sidewalk connections into park from nearby networks are missing
- External site lighting could be energy efficient fixtures
- Baseball fields used as dog runs by users

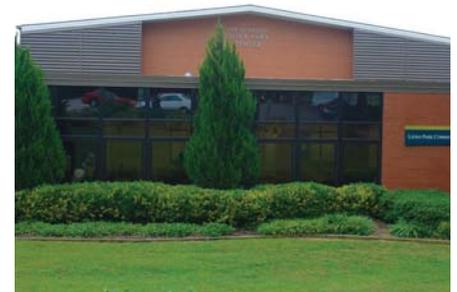
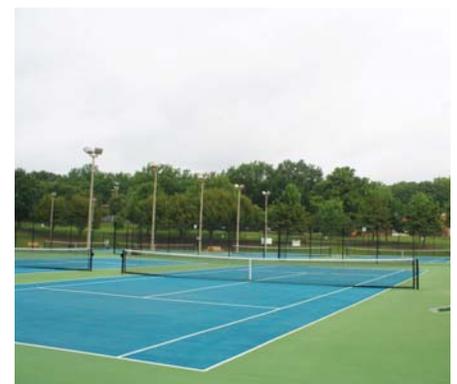
- Treatment of stormwater runoff from paved areas of park is lacking
- Air-Conditioning for gym is not provided
- Pavement in parking lot is cracking and damaged from roots

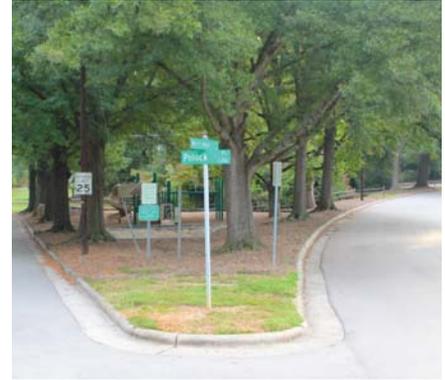
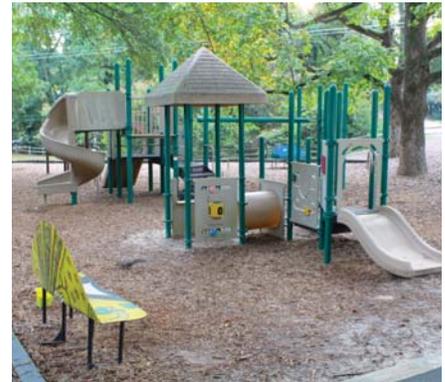
Multi-modal access with bicycle sharrows, parking and transit promotes access. Water management, though limited, can be accommodated on-site and enhanced.

- Activities for a mix of age groups is minimum
- Water management and quality on site could be enhanced
- Crosswalk and direct sidewalk access with accessible playground lacking

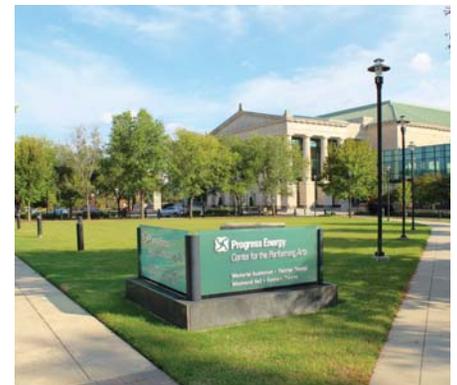
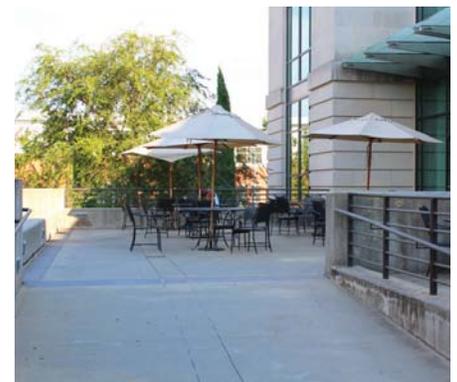
The park is well maintained and very clean throughout. Exterior and interior conditions are good with ample seating choices and protection from weather from multiple buildings and shelters.

Multi-modal access to the park is promoted. Stormwater management is mostly on-site and energy efficiency is minimum in several areas of the park. Co-location of multiple community centers creates a strong civic connection to the park.

- Natural areas of park near NC State Campus are minimally promoted
- Energy efficient lighting could be promoted throughout park
- Interior conditions at community center and aquatics center are poor

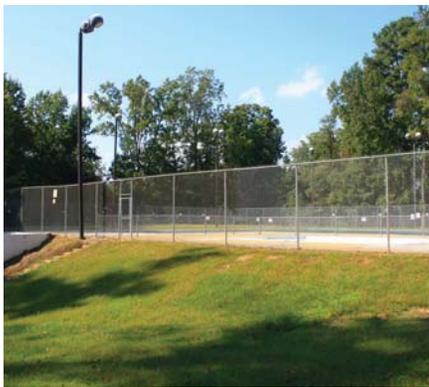
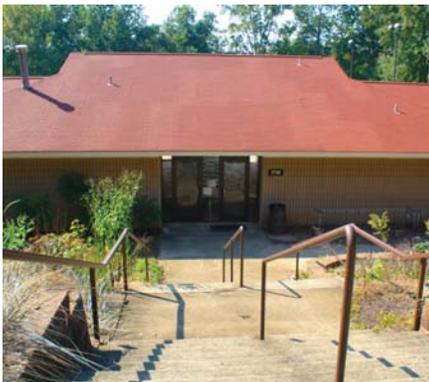
## 6.1.70 - Ridge Road

Ridge Road Park is set back from nearby streets with very limited visibility into the park. Connectivity via sidewalk is provided, however, transit and signage is minimum. Some pavement cracking and maintenance may impact accessibility.

Stormwater is direct runoff from site to adjacent properties. Multi-modal is provided by vehicle, bicycle and pedestrian access. Located adjacent to a middle school, the area promotes co-location of facilities.

- Year-round activities at facility and/or site are minimum
- Multi-modal access to park and school facilities is lacking
- Seating and external shelters for protection from weather are not provided

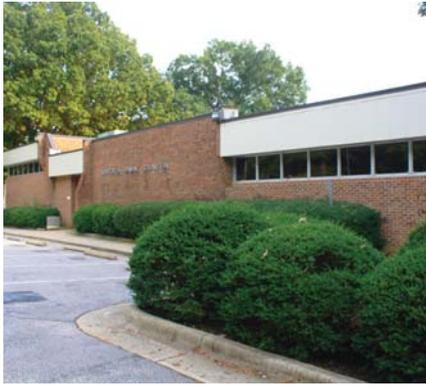
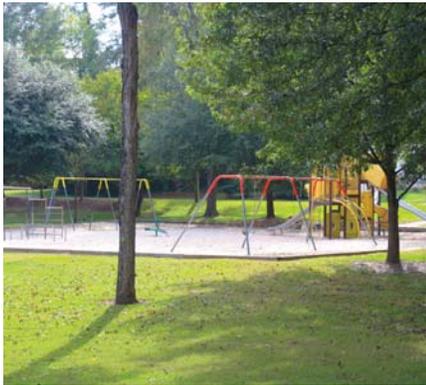
## 6.1.71 - Roberts Size: 7.20 acres

Stormwater is minimally treated on-site and could be improved. Multi-modal access is provided by vehicle, bicycle and pedestrian access. Lighting for fields and courts throughout park is out-dated and may not be energy efficient.

Park is well maintained. Nearby residences provide natural surveillance of the park, while neighborhood center and shelters provide protection from weather.

- On-site stormwater management is minimum
- Accessible routes to facilities such as playground and courts are missing
- Crosswalks to park and energy efficient lighting for courts and fields missing

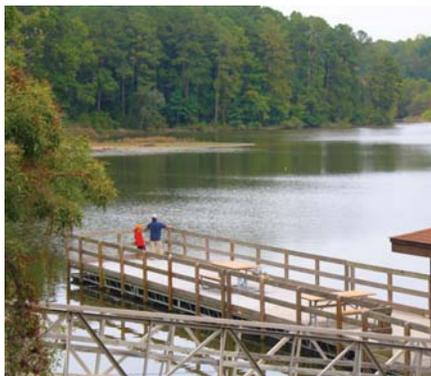
Site has a wonderful natural scenic attraction, however, basketball court and picnic areas are not maintained well. Erosion is problem throughout site. Lake restroom facilities are not accessible and in very poor condition.

Site offers great water management for region, however, runoff from site is untreated before entering lake. Located around a lake and natural area, the park highlights co-location of infrastructure within a park. Multi-modal access is superior to most other parks.

- Restroom facilities at lake are in poor condition
- Accessible routes to lake and crosswalks into park are missing
- Picnic areas with shelters is not provided

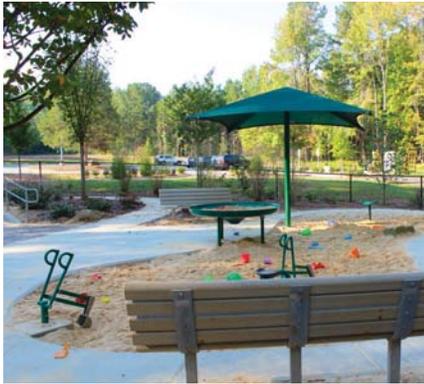
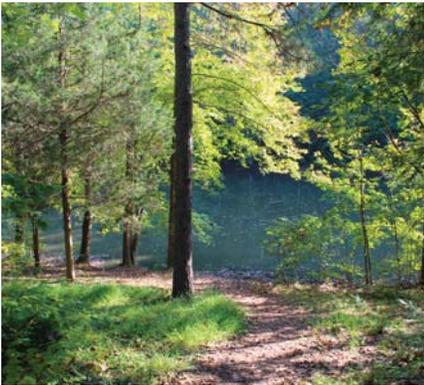
## 6.1.75 - Strickland Size: 36.10 acres

Site includes bio-swales and retention with treatment of stormwater runoff. Solar lighting promotes energy efficiency. Multi-modal access is lacking without direct and safe sidewalk access.

Park is new and very clean. Within park open views to active areas provides safety, however, seating is limited to playground and no protection from weather is currently provided.

- Sidewalk access into park is missing
- Balance natural appeal of site with future development
- Continue energy efficiency and sustainable design for future development

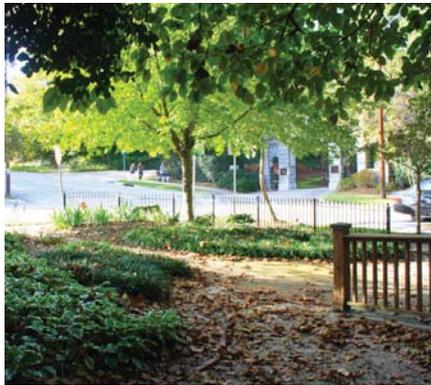
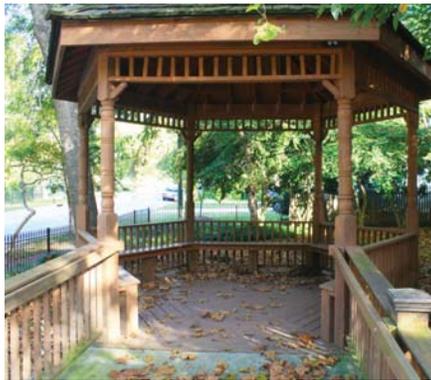
## 6.1.78 - Vallie Henderson

Stormwater is managed on-site and as direct run-off to surrounding streets' closed systems. Lack of bike racks slightly limit multi-modal access to site. Park is adjacent to the Oakwood Cemetery.

- Bike racks and crosswalks at park entrance are missing
- Energy efficient security lighting in shelter could be provided if needed

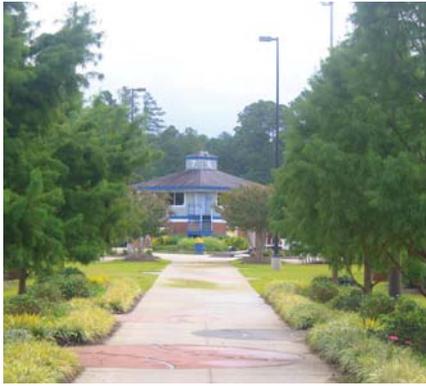
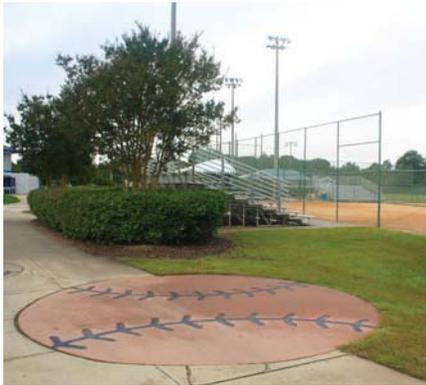
## 6.1.79 - Walnut Creek Softball Complex Size: 104.84 acres

Field stormwater run-off is typically untreated. Vehicle parking areas are mostly gravel which reduces runoff. Multi-modal access is extremely limited with only safe vehicle access into park. Lighting is high intensity due to complex needs.

- Activities and programming for additional age groups, such as playgrounds, wi-fi, additional seating, walking trails, food trucks, etc., are limited
- Stormwater treatment to reduce runoff from fields is minimum

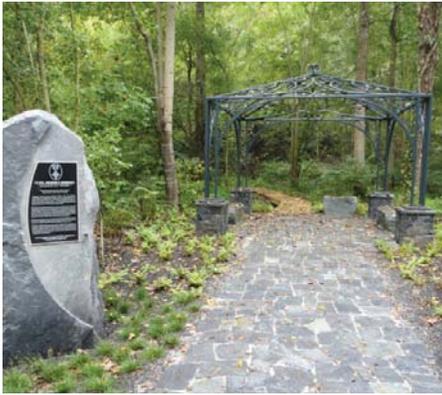
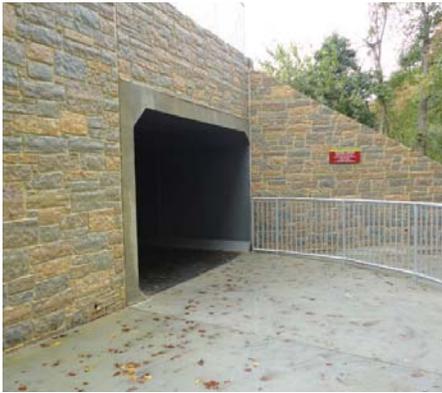
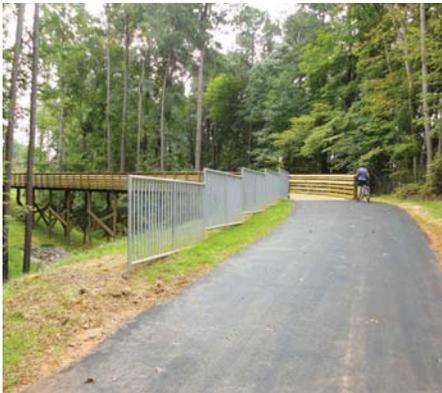
## 6.2.1 - House Creek Trail

Trail striping is missing on most curves and centerlines of the trails. Spur along Horton St. connects to park amenities. Crosswalks are needed along the driveways for safety. The trailhead provides parking for approximately 15 vehicles and includes accessible parking. South of Horton, centerline striping is needed to warn bicyclists of the limited sightlines and steep grades.

House Creek Trail does not have centerline striping. Centerline striping is recommended for transportation trails, and at a minimum, should be installed at

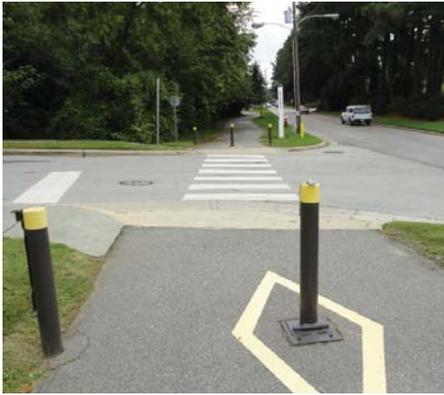
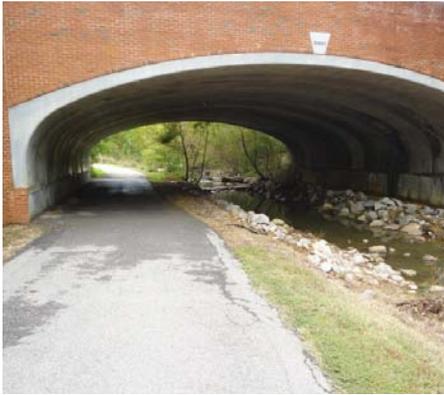
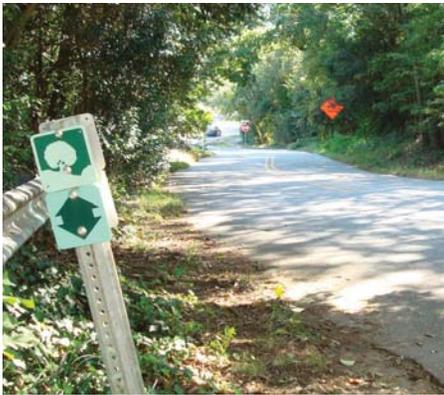
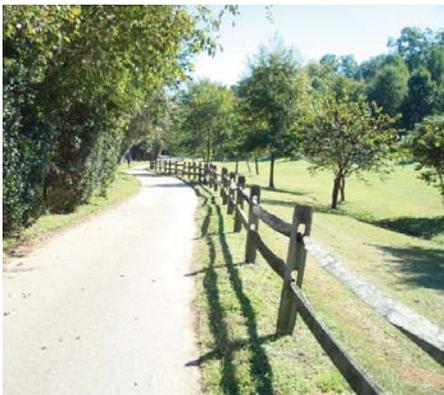
## 6.2.3 - Rocky Branch Trail

- Railings on Western Blvd. are in poor condition
- Asphalt is aging, cracked
- Update wayfinding, kiosks with current signage
- A 10-foot minimum trail width could handle high levels of traffic
- A mural underpass at McDowell would provide a better safety perception
- Pedestrian level lighting at strategic locations would increase hours of operation beyond current dawn to dusk

- Trail cracking in some areas
- Sediment and ponding along some shoulders
- Timber boardwalk is deteriorating in some areas

beginning to show signs of deterioration. The scored concrete along Chavis Way is not bicycle-friendly. There are some drainage problems north of the Cabarrus St. intersection. There are negative perceived safety concerns where the trail extends through Chavis Park due to loitering and poor site lines.

- Asphalt near and along Chavis Park is in poor condition
- Increased patrols at Chavis Park could increase perceived safety
- Number of all wayfinding, interpretive, and kiosks with current signage is minimum
- Roadway intersections with ADA-compliant curb ramps and high visibility crosswalks are lacking
- Mid-block crossing with signage at Bragg Street is missing
- Trail width is below 10 feet

A study is recommended at the intersection of Jamaica and Saunders. The underpass at Dawson/Western/McDowell is lit, however the inside would benefit from a mural or other inviting element.

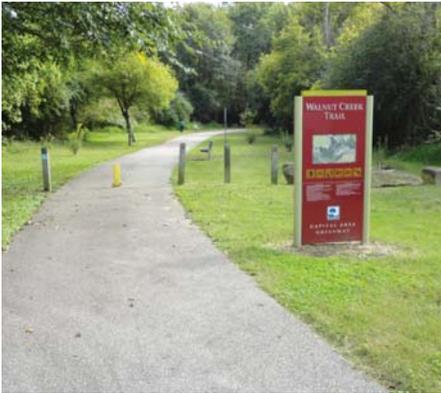
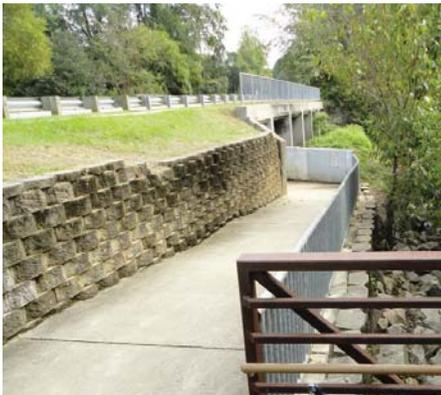
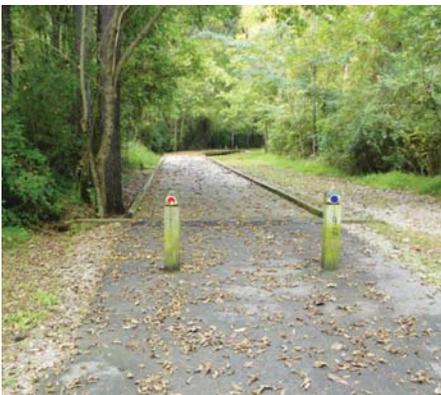
## 6.2.5 - Walnut Creek Trail - WCT-A

- Underpasses are not lit and lacks regulatory signage, vertical/horizontal clearance is limited
- Poor site lines at underpass
- Trail tread in very poor condition
- Areas in need of maintenance
- Vandalism of mile markers, littering

The underpass at Rock Quarry Rd. has very low clearance, no lighting, sediment and moisture, and inadequate signage

and striping at entrance. Sections of the tread along this segment are in poor condition with slippery conditions, sediment deposits, and litter. There is vandalism of several mile markers and some areas in need of railing.

The tread is in very poor condition. There are sediment deposits, mud, downed limbs, and slippery conditions on the tread. Boardwalk areas are in disrepair. At Rose Ln, a better transition is needed for safety and user clarity. Where the trail becomes an on-road facility, sharrows or other bike route signage is needed.

- Reconstruct/reroute areas in disrepair
- Raised tread and surface damage present
- Maintenance may be lacking with litter present
- Wayfinding signage along corridor is minimum
- Safety issues at underpasses present
- Signage is vandalized
- Railing is lacking in some areas where appropriate

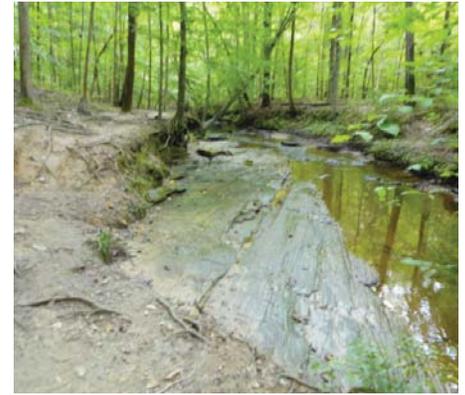
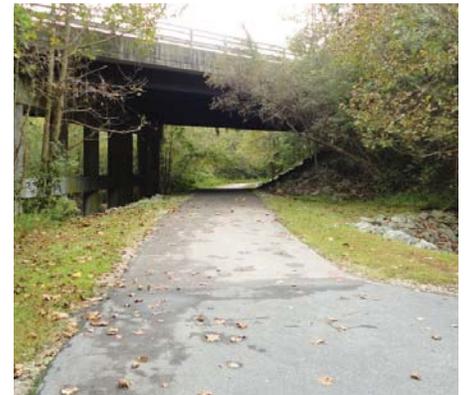
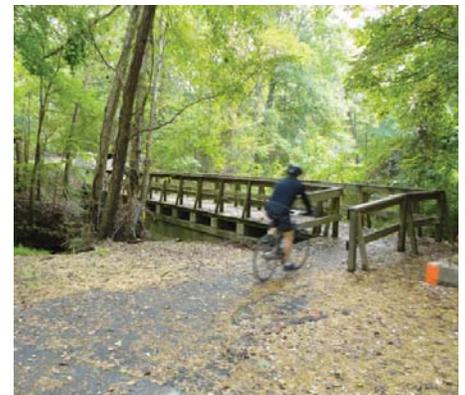
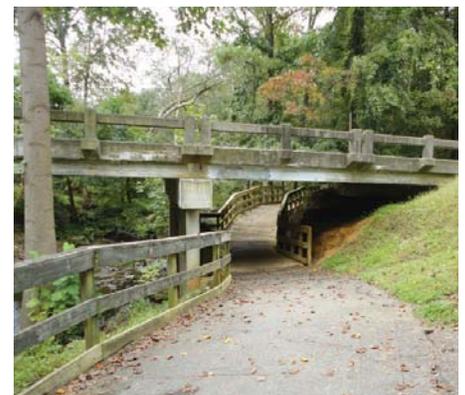
- Sediment, ponding, washing out along shoulders
- Downed branches
- Drainage issues of concern with tread slumping, flooding near Milbrook

Tread condition is in poor condition in some areas due to drainage issues. Trail lacks functional shoulders due to washout.

The underpasses are very unsafe along this segment, and include boardwalks,

dark conditions, and are too narrow to accommodate bicyclists. Much of the tread is in very poor condition with slumping, flooding, and the subgrade being undermined during storm events. In some areas, the width narrows to 6-8 feet, which may need reconstruction. Some areas have very bad flooding.

- Drainage issues present and shoulders need repair
- Underpass at Millbrook is efficient
- Trail's width is currently below 10 feet
- Regulatory and wayfinding signage is lacking
- Lighting, striping, and warning signage at underpasses are minimum
- Crossing facility at North Hills Dr. is minimum
- ADA accessibility at curb ramps, bridges, and underpasses is minimum

Boardwalk may need replacement in coming years. City may consider more durable lasting material such as concrete boardwalk. The at-grade crossing at North Hills Dr. has concrete sidewalk that could be widened to 10' and a flashing beacon may be installed. All curb ramps need truncated domes and ADA accessible curb ramps.

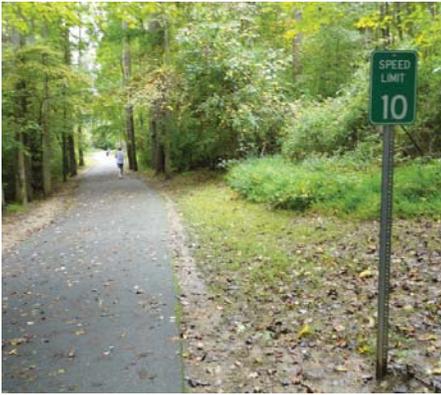
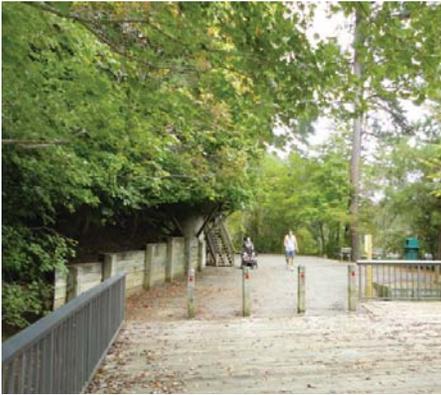
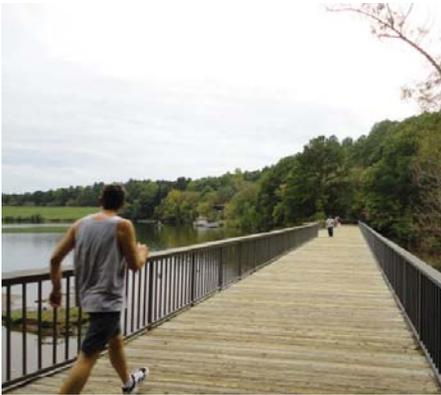
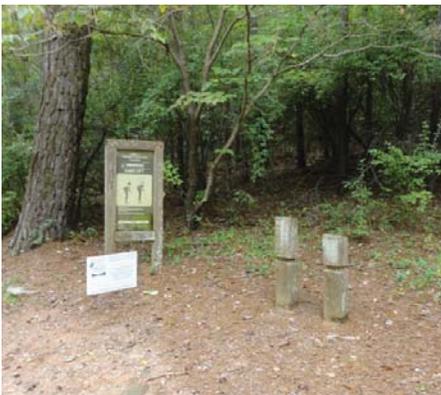
## 6.2.7 - Shelley Lake Trail

- Trail surface is aging, cracking, tree roots (esp. at lake)
- Some ponding/sediment
- Timber boardwalk is deteriorating

- Trail may be too narrow to support such high level of use
- Slopes are steep on south side of trail
- Cross slopes are steep in some areas (not ADA compliant)

At the southeastern portion of the lake, the grades are steep and not accessible.

- Trail width is minimum for high level and variety of uses
- Asphalt is aged and needs repair
- Wayfinding and regulatory signage at intersections and parking area is lacking
- Trail etiquette signage are not provided
- Existing boardwalk is in poor condition
- Recycling receptacles are not provided
- Fitness stations are aging/deteriorating

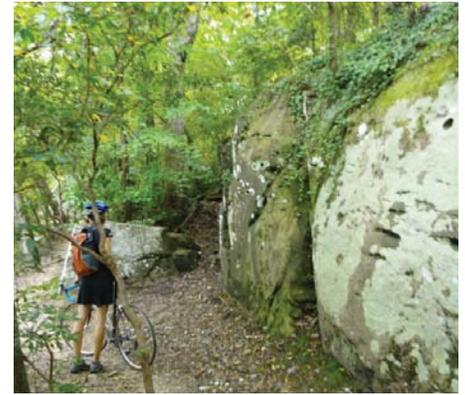
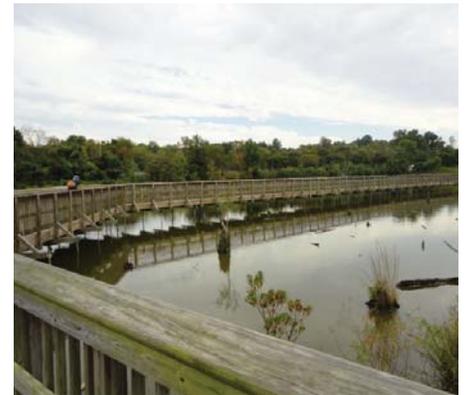
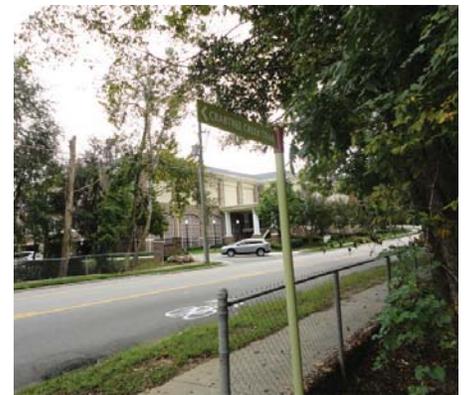
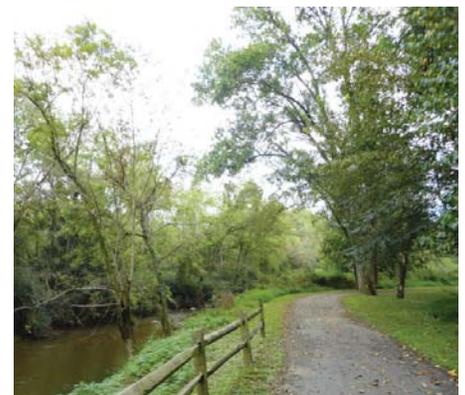
- Edges are crumbling in areas
- Some ponding, but overall not problematic

Bridges are in nice condition. Informal trailhead at Anderson lacks accessible parking. The crossing facility at Anderson is well treated with a median refuge island and crosswalk. Wayfinding at trail intersections.

Majority of this segment includes long stretches of elevated boardwalk in good condition. Wayfinding/ regulatory signage needed where tread condition changes.

- Pedestrian bridge just south of I-440 does not provide 2-way pedestrian traffic and ADA access
- Signage lacking or rerouting needed where pavement ends near Hertford St.
- Wayfinding signage is minimum
- Lighting and regulatory signage at Capital Blvd. underpass is missing
- Roadway/trail intersection at Milburnie Rd. is minimum

Update old and deteriorating mile markers along this segment for consistency. Roadway intersection needs study to determine appropriate safety improvements.

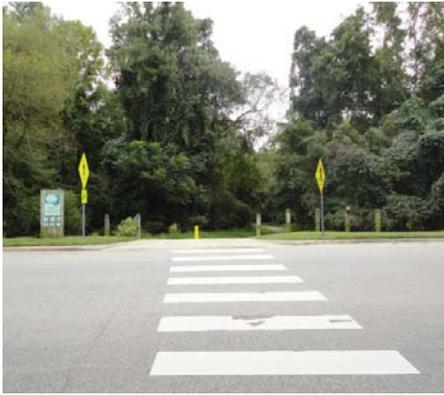
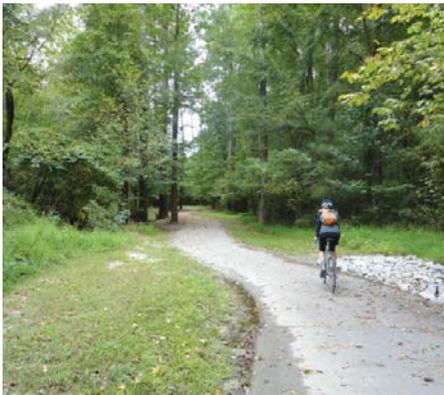
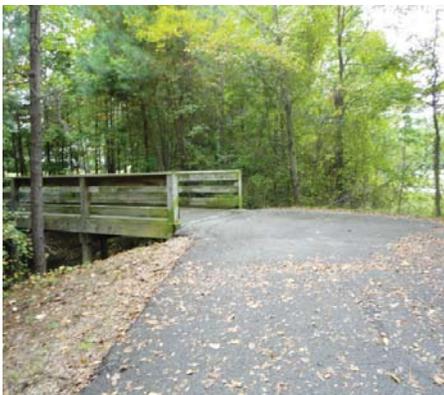
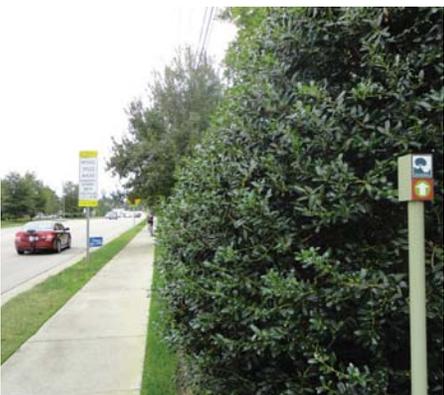
## 6.2.9 - Simms Branch Trail

- Drainage issues are being addressed, but some ponding is still occurring
- Tread is aging, cracking in some areas

Trail is aged and cracking in places due to roots. Resurfacing needed areas. Some locations areas contain ponding issues but are being address. Cross slopes on some sections are steep

- Some areas of asphalt are crack and aged due to root damage
- Wayfinding/mile markers in to be updated

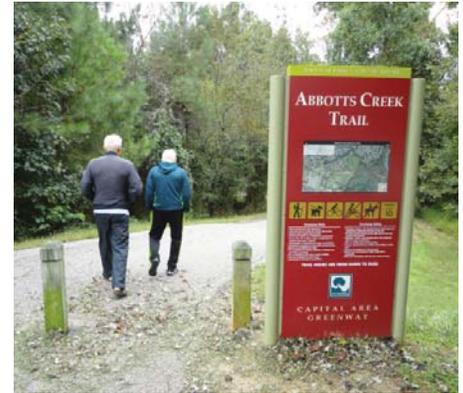
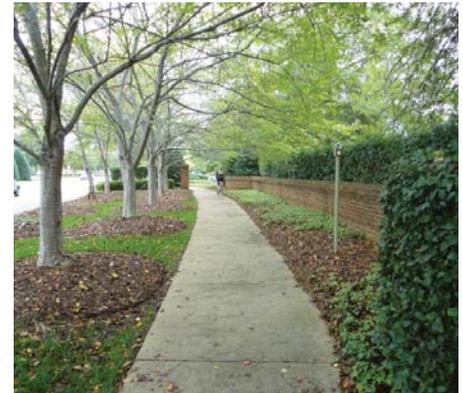
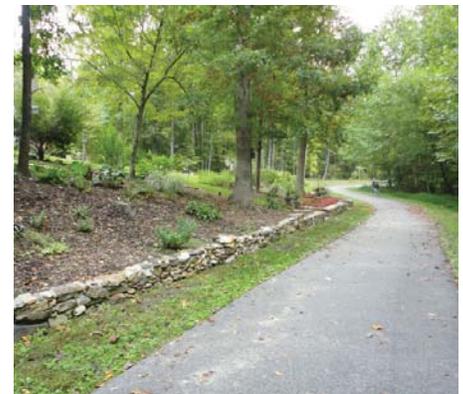
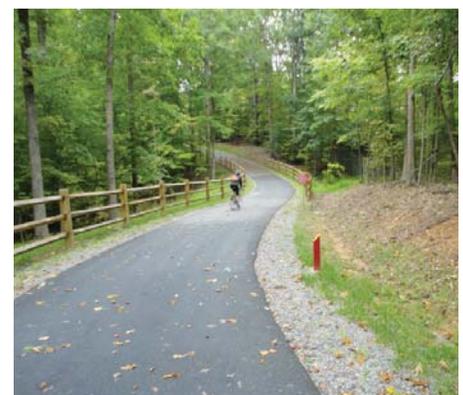
- Sufficient

- Trail entrances at Falls River Ave. and Durant Rd. lacks high visibility crosswalks
- Traffic calming and driveway crossing facilities on Falls River Ave. missing
- Centerline striping at Falls River Ave. entrance missing
- Sidewalk travel area not clear along Falls River Ave. due to vegetation
- Sidewalk and bike lane facilities are minimum
- Wayfinding signage could more visible when connecting on-road facilities to off-road facilities

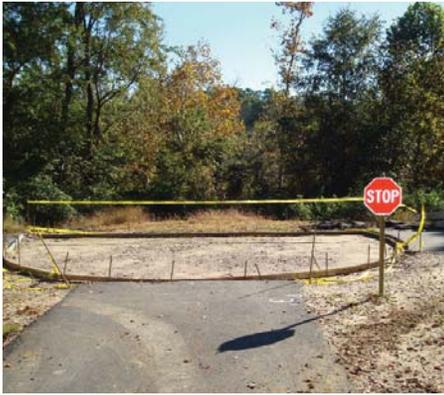
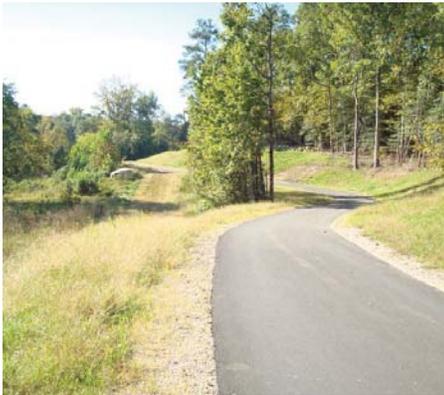
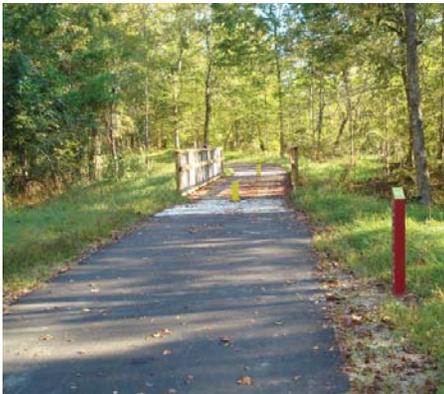
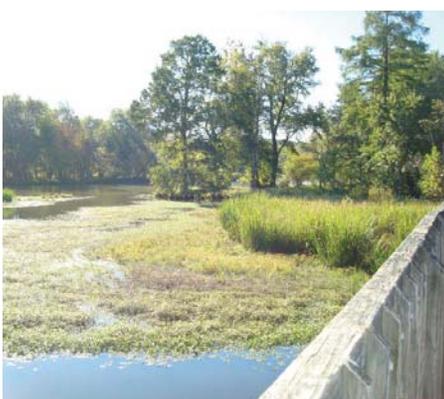
## 6.2.11 - Neuse River Trail

- Bollards at bridges are unnecessary and a safety hazard
